# Evaluating the Performance of Irregular Low-Rise RC Building Through Static Non-Linear Pushover Analysis

## Abstract

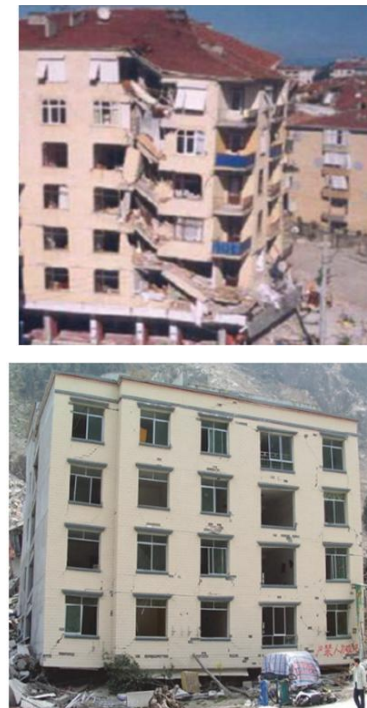
Fig. 3. Damages of the plan and vertical irregularity after the earthquake [13]

Both horizontal and vertical irregularities prevent an equal transmission of damage, making it impossible to manage the system's strength and ductility fully. Therefore, this kind of configuration needs to be avoided. Figure 3 shows how the plane and vertical irregularity are damaged due to the seismic load.

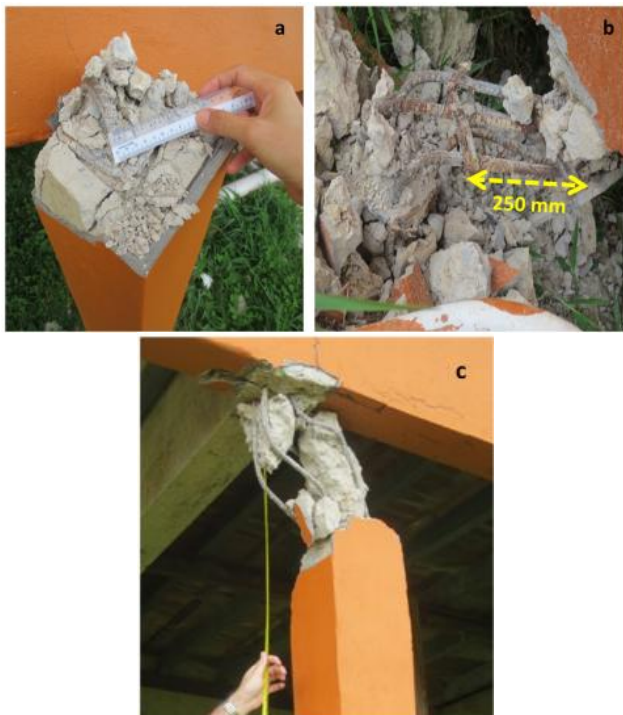
Fig. 4. Large spacing between stirrup in columns [19]

Several of the analysed RC structures showed a lack of transverse reinforcement, particularly in the positions of the plastic hinges. Figure 4 shows the damaged columns of 2-storey RC building in Sabah.

Figure 4a shows the column underwent severe damage to its upper side and concrete spalling, causing it to separate from the supporting beams. Columns should have a minimum dimension of 300 mm or 250 mm, according to seismic code requirements, in order to decrease axial stress and improve ductility. Meanwhile, all the column in this building is 200×200mm which not according to the design codes. In Figure 4b, the gap between stirrups in columns was 250 millimetres, and there was no reduction in distance at the plastic hinge points. From Figure 4c, the bulk of the structures in the impacted region had widely spaced stirrups. The longitudinal reinforcements of columns were measured to be 12 mm in diameter, whereas the transverse reinforcements were measured to be 10 mm shown in Figure 5. It should be noted that seismic design rules require a longitudinal bar diameter of at least 14 mm to prevent buckling.

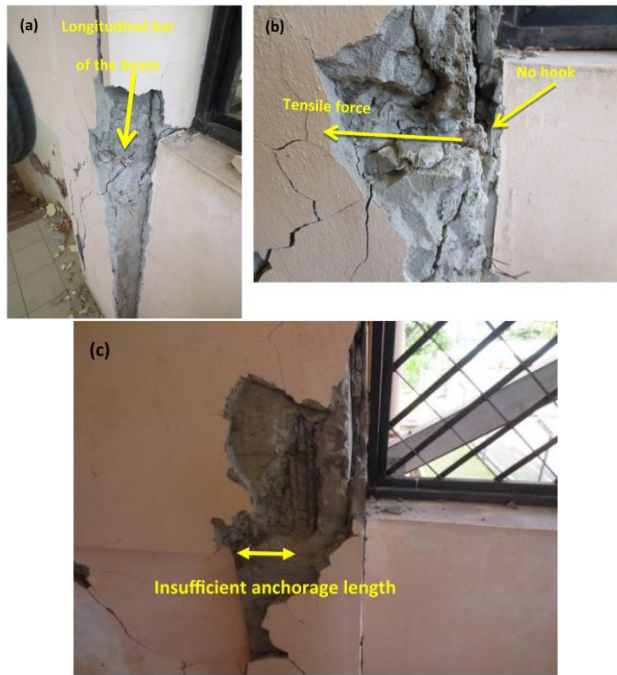
Fig. 6. The insufficiency of anchoring at the end of the reinforcing bar causes column damage [19].

Figure 6 shows the insufficient hooks and anchoring in beam to column joints. As can be seen from Figure 6(a), there is no hook for longitudinal reinforcement of the beam. Figure 6(b) shows that stress accumulation at the end of the reinforced rebar has caused huge fractures and concrete shattering. Figure 6(c) shows another beam's end side, when the longitudinal reinforcements' anchoring length was insufficient. It should be noted that seismic design rules need appropriate details for reinforcement rebar anchorage. Transverse reinforcements, for example, should feature 135° hooks to provide solid couplings during an earthquake. Nevertheless, the majority of the examined constructions utilised smooth transverse bracing with 90° hooks. [19].

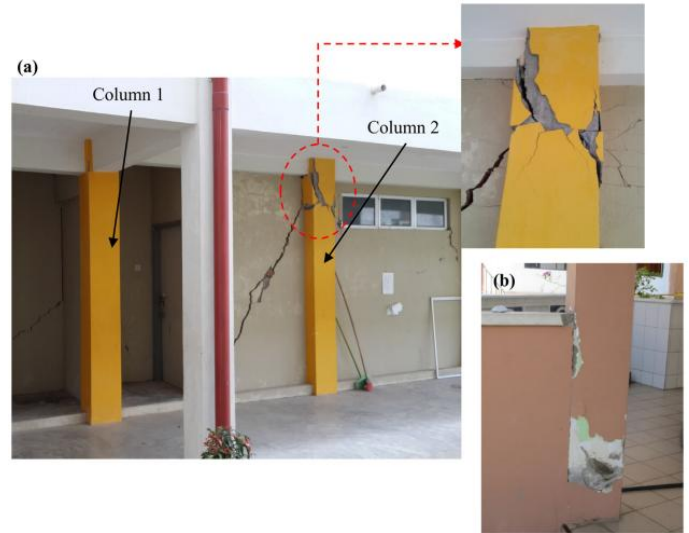
Fig. 8. Captive column occurrence [19]

Figure 8 and Figure 9 show the effect of captive and short column occurrences. The first scenario shows two columns with comparable proportions constructed adjacent to each other. Column 1 has withstood the earthquake because it is not confined by the brick wall. Column 2 shows major shear fractures on its top part, where a window is installed into the brick infill wall. This figure clearly illustrates that Column 2 was already completely obstructed on its left side by a brick wall. The upper section of the column on the right side is not constrained by the brick wall. Shear load in the column has increased due to the captive column effect [19].

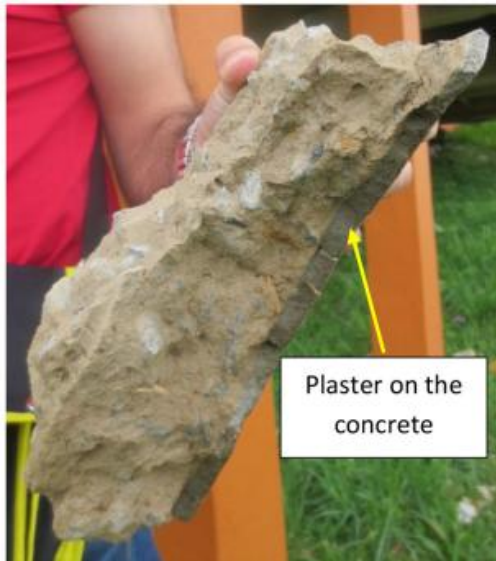
Fig. 10. A portion of the column that was severely damaged during the earthquake [19].

and the usage of river water to build the mortar [19]. Figure 10 show the low-quality concrete coated by thick layer of plaster.
